PENNSYLVANIA  
**BENTLEYVILLE DAM LEVEL II**

NDI ID NO. PA-1096

PHASE I INSPECTION REPORT  
NATIONAL DAM INSPECTION PROGRAM

L. ROBERT KIMBALL & ASSOCIATES  
CONSULTING ENGINEERS & ARCHITECTS  
EBENSBURG, PENNSYLVANIA  
15931

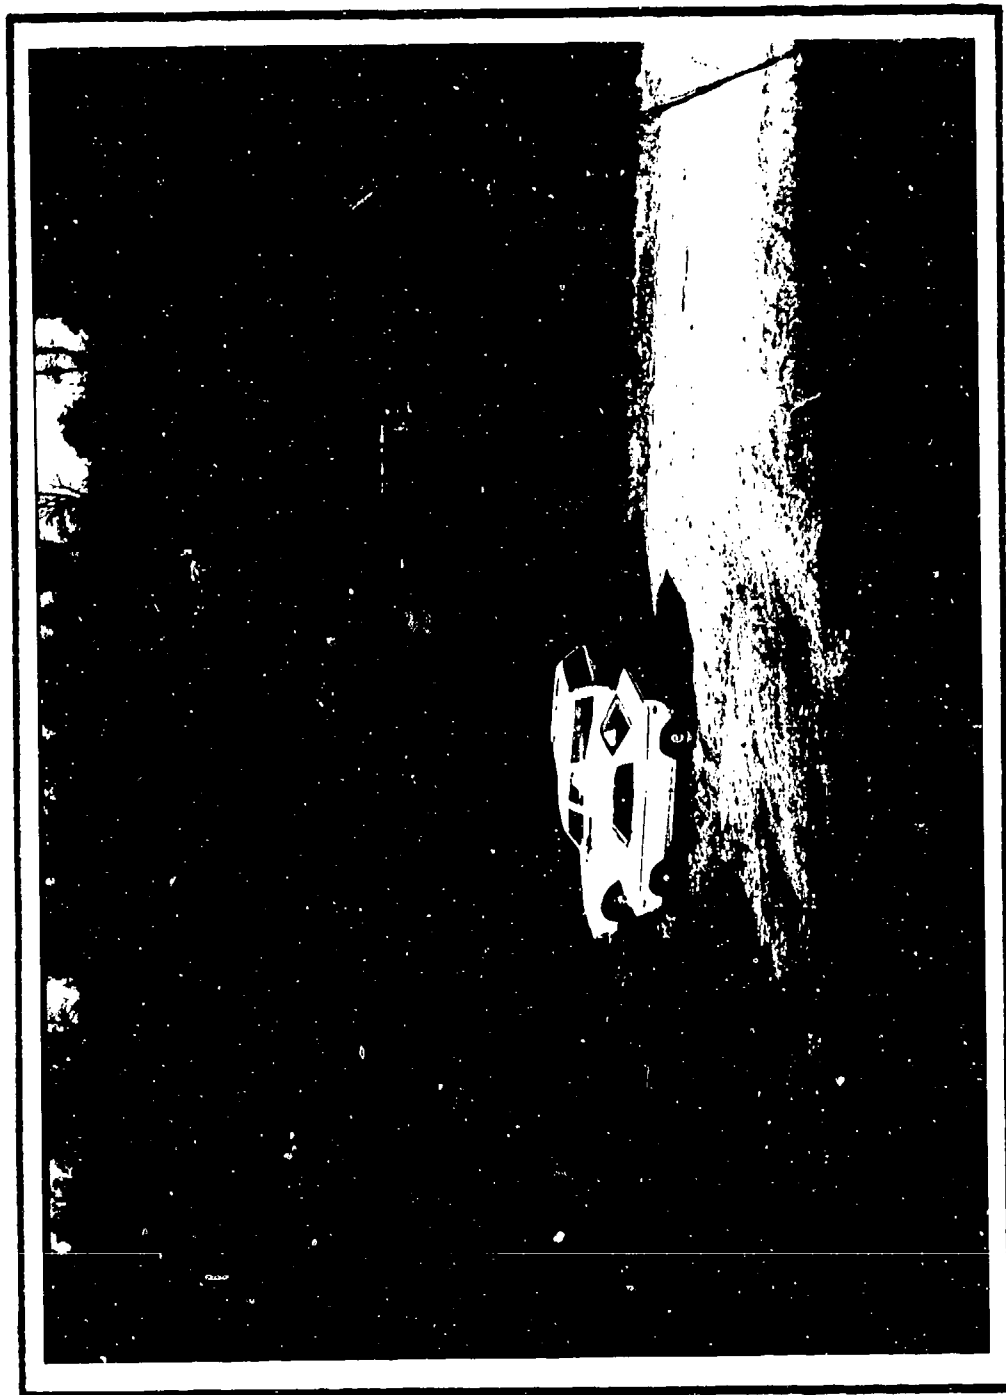
Overview of Bentleyville Dam.
